Saraland Water and Sewer Service Completes Emergency Repair of Damaged Infrastructure

EMERGENCY SEWER - CELESTE ROAD AT I-65
SARALAND, ALABAMA

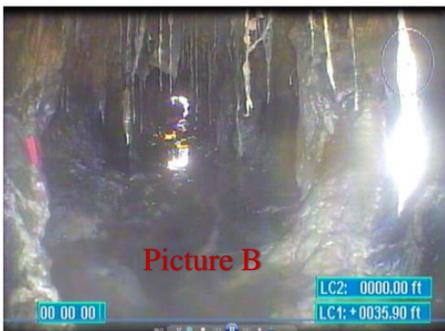
EXISTING PIPE CONDITION FROM INITIAL VIDEO

In order to address the extent of the damage, the Saraland Water Board, using the expertise of Carah Hall, PE from McCrory Williams Inc., hired Smith Industrial Service (SIS), a local company who uses innovative technology to assess the condition of underground infrastructure. First, SIS ran a camera through the broken line to visually determine the interior condition of the pipe (see picture B). After additional considerations and further evaluations of the video inspection, it was determined that the pipe segment was conducive for a point repair at the break and complete rehabilitation in-place with minimal disruption, using Cured-in-Place Pipe methods. Cured-in-Place Pipe (CIPP) methods uses trenchless technology to install a high-strength fiberglass resin liner inside an existing host pipe.

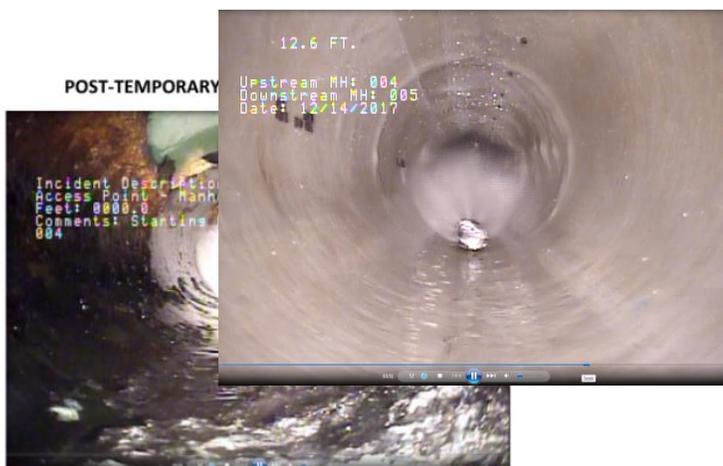
EXISTING 18" CAST IRON SEWER PIPE BREAK

After the point repair was made and during low flow conditions, the Contractor was able to complete the repair by cleaning the existing pipe and installing a new CIPP liner within the existing pipe (see pictures C and D). The cost of the permanent emergency repair, including the temporary emergency repair and engineering, was approximately \$100,000. The Saraland Water and Sewer Board Members and staff are committed to maintaining and improving its infrastructure in order to secure adequate sewer service and keep down rates for their valued customers.
