**SANITARY SEWER COLLECTION SYSTEM MASTER PLAN
FINAL REPORT**
BOARD OF WATER AND SEWER COMMISSIONERS OF THE CITY OF SARALAND
PROJECT No. 1074304
JUNE 2022

SANITARY SEWER FLOW STUDY

By: CLS Services, Inc.

SANITARY SEWER FLOW STUDY FOR THE BOARD OF WATER AND SEWER COMMISSIONERS
OF THE CITY OF SARALAND
October 7, 2021

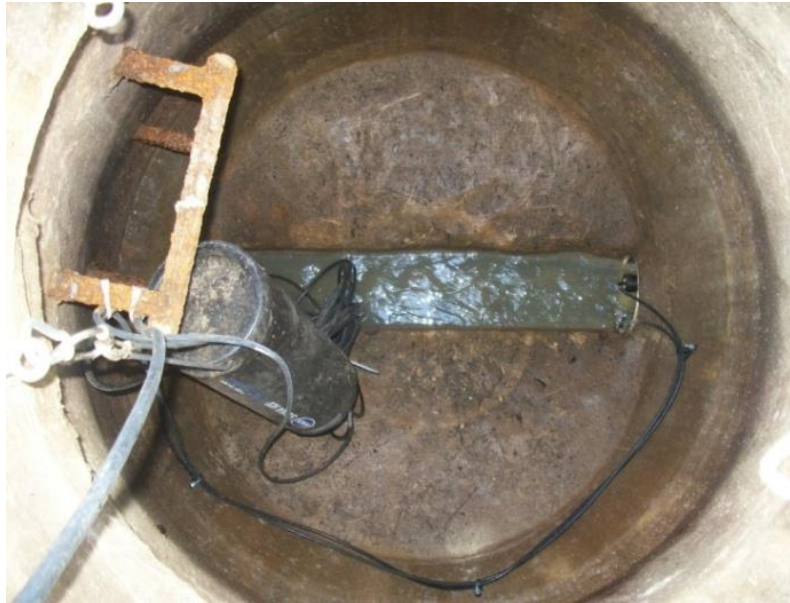
Photograph 1. Typical Flow Meter Installation

CSL technicians completed the installation of the 6 FloWav flow meters and 1 Texas Electronics tipping bucket rain gauge on March 18, 2021. **Photograph 1** presents a typical flow meter installation.

These flow meters were programmed to record depth and velocity readings at 15-minute intervals. Initial calibration consisted of no less than three independent verifications of both velocity and depth readings. Through wireless telemetry the data was uploaded each night to a secure website. The Phase 1 data collection period lasted from March 18, 2021 until the 4 of the meters were removed on June 15, 2021. The Phase 2 data collection period began on June 17, 2021 and lasted until August 18, 2021. All equipment was removed on August 19, 2021.

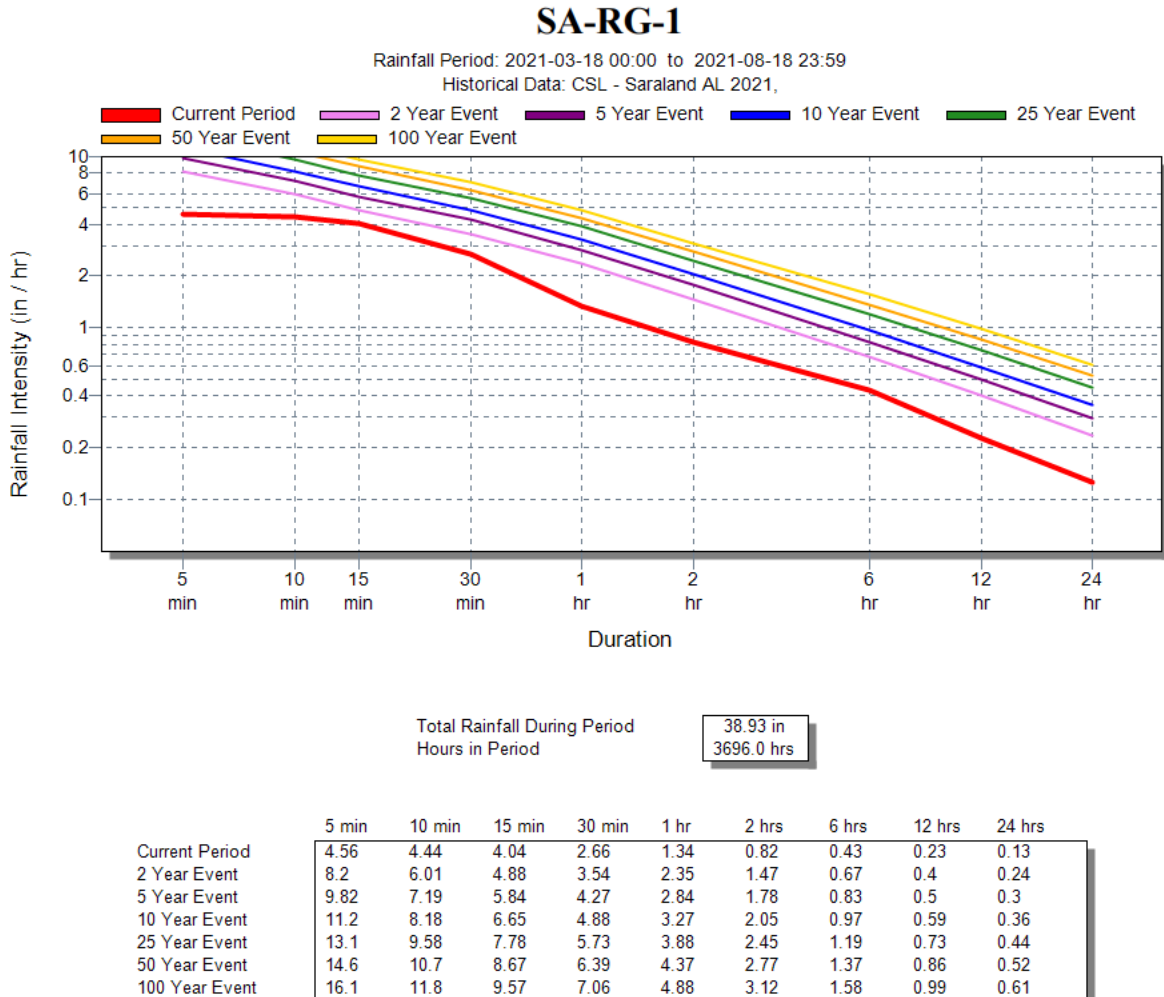
Figure 4. IDF Curves and Rainfall Recorded at RG-1

Intensity Duration Frequency Curves for Saraland were taken from the National Weather Service Hydrometeorological Design Studies Center Precipitation Frequency Data Server. **Figure 4** below presents these IDF curves compared with the rainfall recorded during both phases this study.

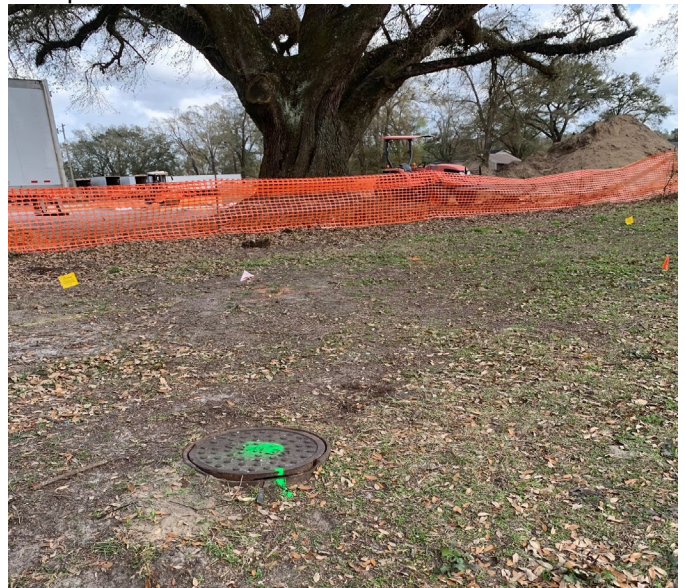
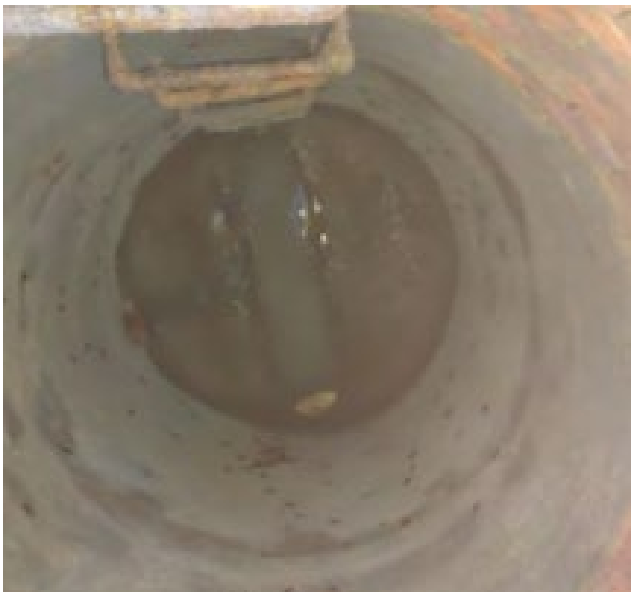
Area photo

Project: Saraland TFM 2021		Date: 3/16/21	Name: J. Rodgers
Manhole #: SA-43-00-102	Pipe Diameter: 10"	Pipe Material: VCP	
Address/Location: 226 Saraland Blvd S			
Town: Saraland			
Latitude: N 30°48.90096'		Longitude: W 88°04.25934'	Access: Drive
Safety: Standard, CSE		Manhole Depth: 10'7"	
Gas Investigation: Good	Manhole Condition: Fair	Traffic: Standard	
Flow Meter: Flowav	Serial #: 294999	Sensor Configuration: pressure depth, Doppler Velocity

Site Comments: evidence of surcharge. Sensor is installed in the upstream pipe.

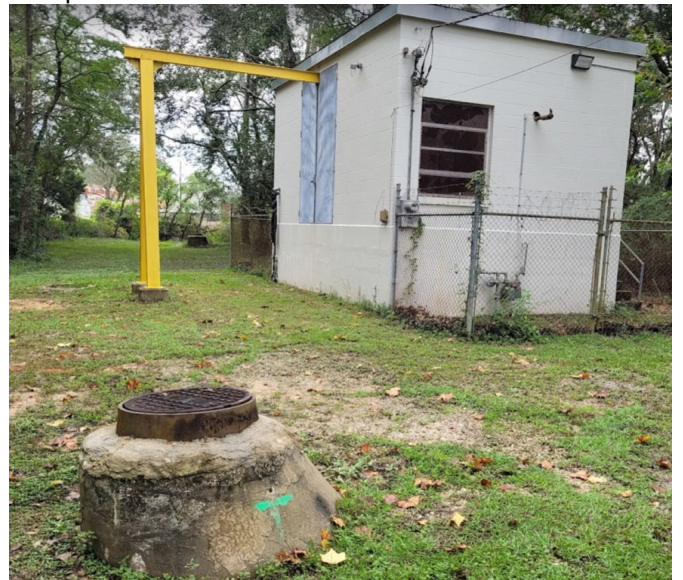
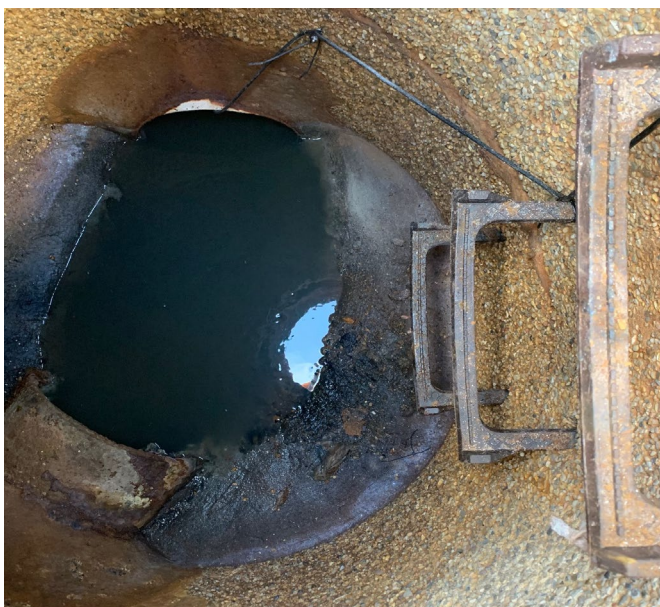
Area photo

Project: Saraland TFM 2021		Date: 3/16/21	Name: J. Rodgers
Manhole #: SA-BS-22-001	Pipe Diameter: 15"	Pipe Material: PVC	
Address/Location: 188 Saraland Blvd N			
Town: Saraland			
Latitude: N 30°49.53474'		Longitude: W 88°04.14606'	Access: Drive
Safety: Standard, CSE		Manhole Depth: 6'2"	
Gas Investigation: Good	Manhole Condition: Fair	Traffic: Standard	
Flow Meter: Flowav	Serial #: 293375	Sensor Configuration: pressure depth, Doppler Velocity

Site Comments: evidence of surcharge. Sensor is installed in the upstream pipe.

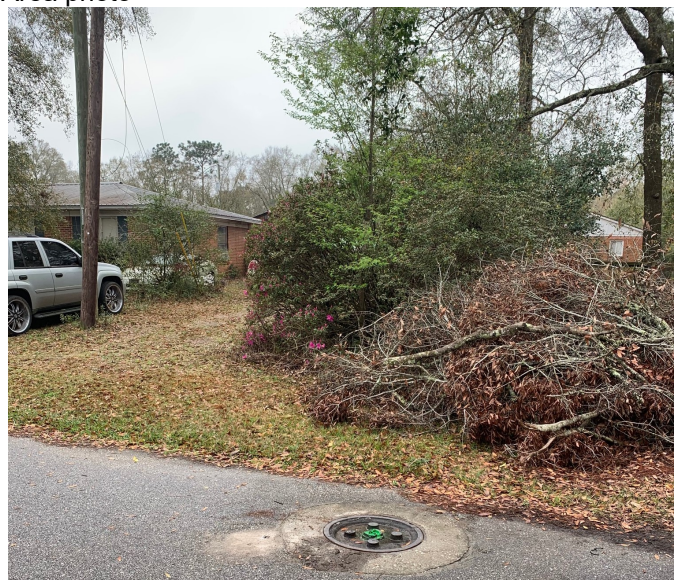
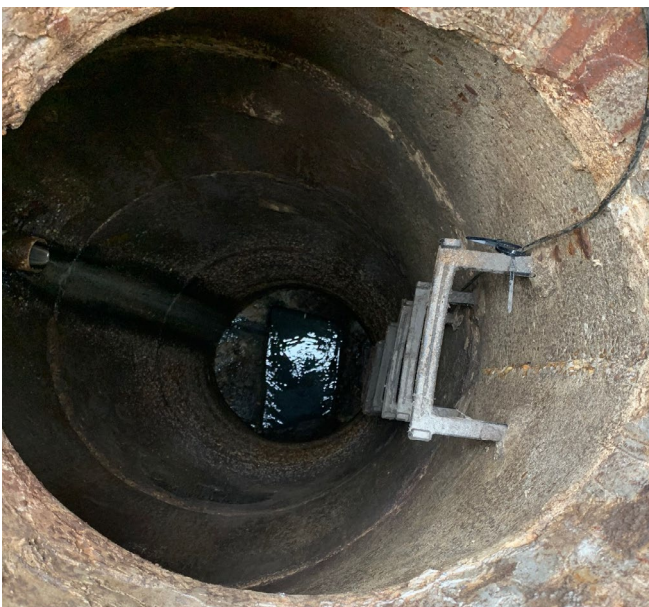
Area photo

Project: Saraland TFM 2021		Date: 3/17/21	Name: J. Rodgers
Manhole #: SA-EC-00-001	Pipe Diameter: 20"	Pipe Material: RCP	
Address/Location: 217 Frances St			
Town: Saraland			
Latitude: N 30°48.99174'		Longitude: W 88°04.62288'	Access: Drive
Safety: Standard, CSE		Manhole Depth: 17'8"	
Gas Investigation: Good	Manhole Condition: Fair	Traffic: Standard	
Flow Meter: Flowav	Serial #: 295806	Sensor Configuration: pressure depth, Doppler Velocity

Site Comments: evidence of surcharge. Sensor is installed in the upstream pipe.

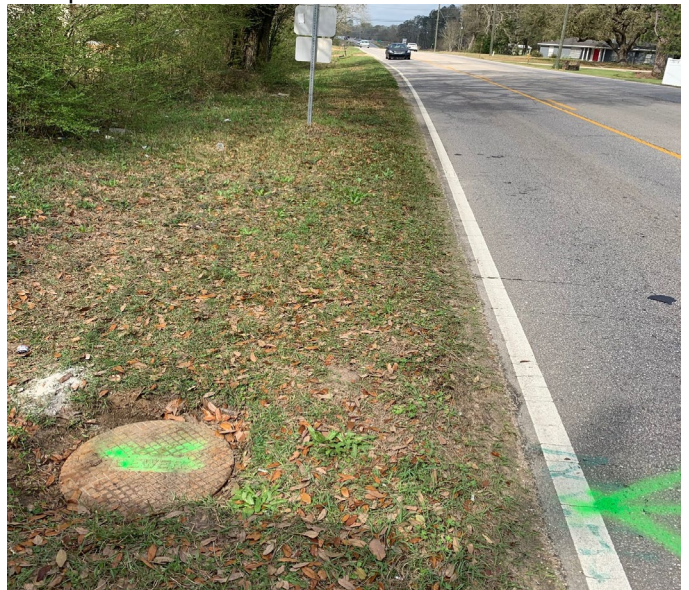
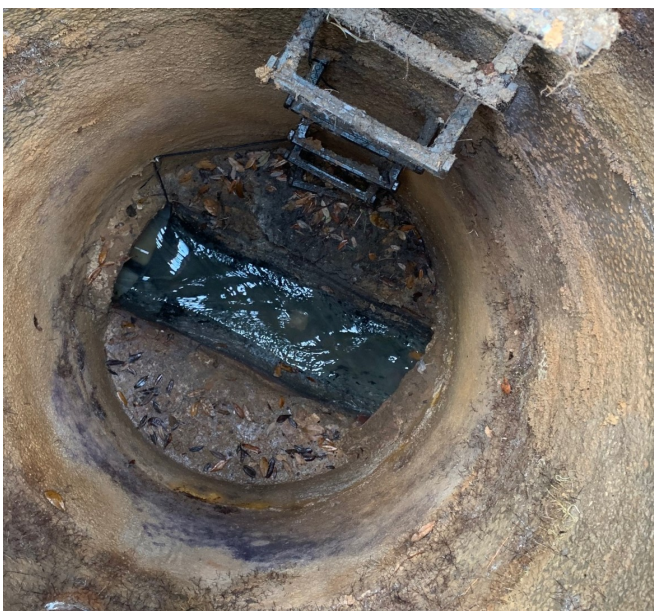
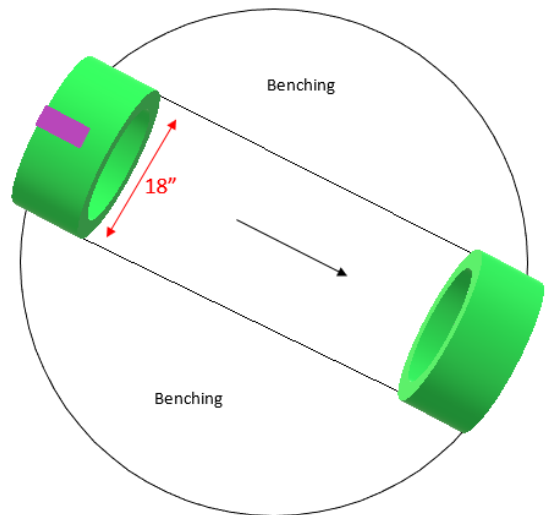
Area photo

Project: Saraland TFM 2021		Date: 3/17/21	Name: J. Rodgers
Manhole #: SA-EC-00-029	Pipe Diameter: 18"	Pipe Material: CIP	
Address/Location: Across from 301 E Ponce De Leon Dr			
Town: Saraland			
Latitude: N 30°49.71606'		Longitude: W 88°04.9446'	Access: Drive
Safety: Standard, CSE		Manhole Depth: 10'	
Gas Investigation: Good	Manhole Condition: Fair	Traffic: Standard	
Flow Meter: Flowav	Serial #: 293665	Sensor Configuration: pressure depth, Doppler Velocity

Site Comments: evidence of surcharge. Sensor is installed in the upstream pipe.

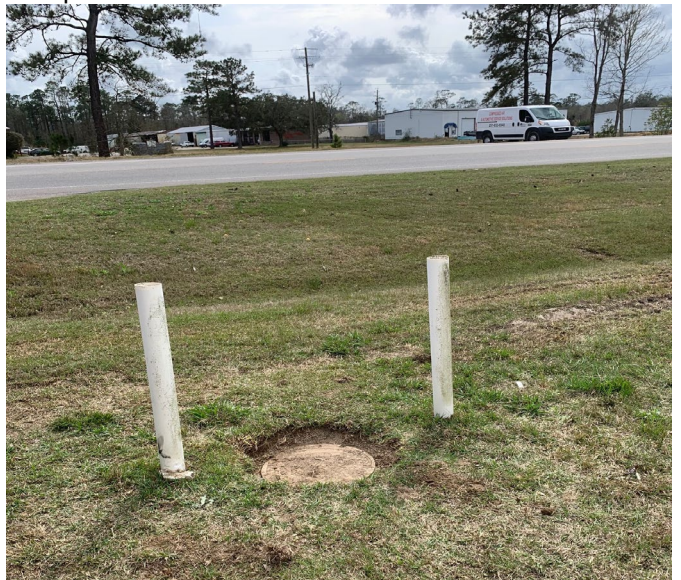
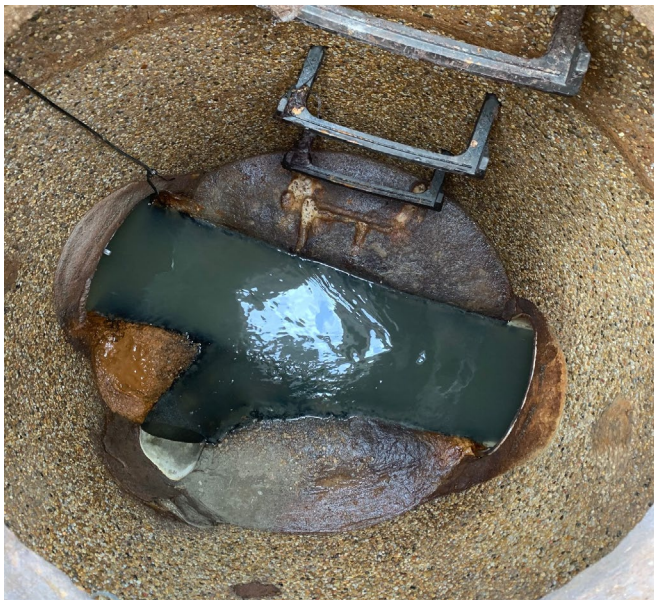
Area photo

Project: Saraland TFM 2021		Date: 3/16/21	Name: J. Rodgers
Manhole #: SA-IP-03-113	Pipe Diameter: 18"	Pipe Material: PVC	
Address/Location: 126 Industrial Pkwy			
Town: Saraland			
Latitude: N 30°47.73726'		Longitude: W 88°04.64394'	Access: Drive
Safety: Standard, CSE		Manhole Depth: 6'	
Gas Investigation: Good	Manhole Condition: Fair	Traffic: Standard	
Flow Meter: Flowav	Serial #: 294568	Sensor Configuration: pressure depth, Doppler Velocity

Site Comments: no evidence of surcharge. Sensor is installed in the upstream pipe.

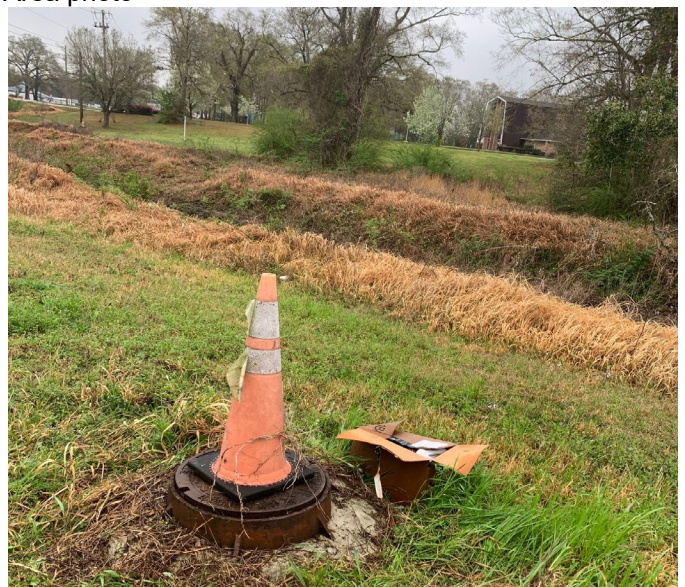
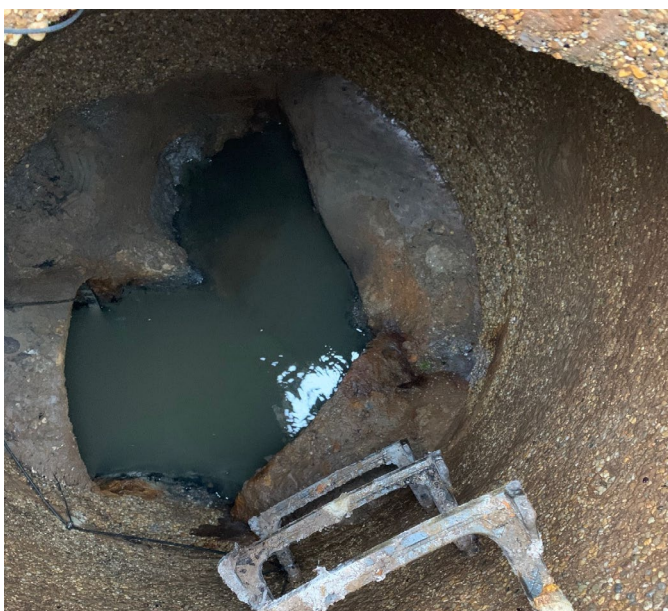
Area photo

Project: Saraland TFM 2021		Date: 3/17/21	Name: J. Rodgers
Manhole #: SA-NC-00-001	Pipe Diameter: 30"	Pipe Material: CIP	
Address/Location: 217 Hwy 43			
Town: Saraland			
Latitude: N 30°49.00806'		Longitude: W 88°04.29372'	Access: Drive
Safety: Standard, CSE		Manhole Depth: 9'1"	
Gas Investigation: Good	Manhole Condition: Fair	Traffic: Standard	
Flow Meter: Flowav	Serial #: 294548	Sensor Configuration: pressure depth, Doppler Velocity

Site Comments: no evidence of surcharge. Sensor is installed in the upstream pipe.

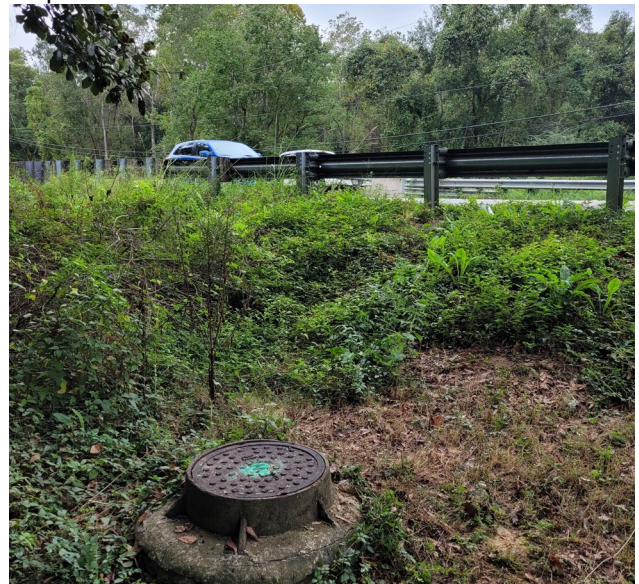
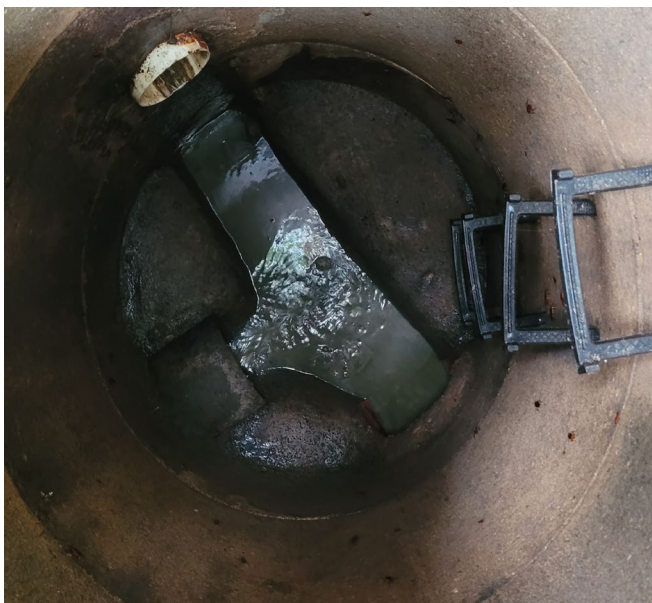
Area photo

Project: Saraland TFM 2021		Date: 6/16/21	Name: J. Rodgers
Manhole #: SA-NC-00-023	Pipe Diameter: 12"	Pipe Material: CIP	
Address/Location: Shelton Beach Rd near guardrail			
Town: Saraland			
Latitude: N 30°48.95904'		Longitude: W 88°05.19954'	Access: Walk
Safety: Standard, CSE		Manhole Depth: 10'5"	
Gas Investigation: Good	Manhole Condition: Fair	Traffic: Standard	
Flow Meter: Flowav	Serial #: 294999	Sensor Configuration: pressure depth, Doppler Velocity

Site Comments: evidence of surcharge. Sensor is installed in the upstream pipe.

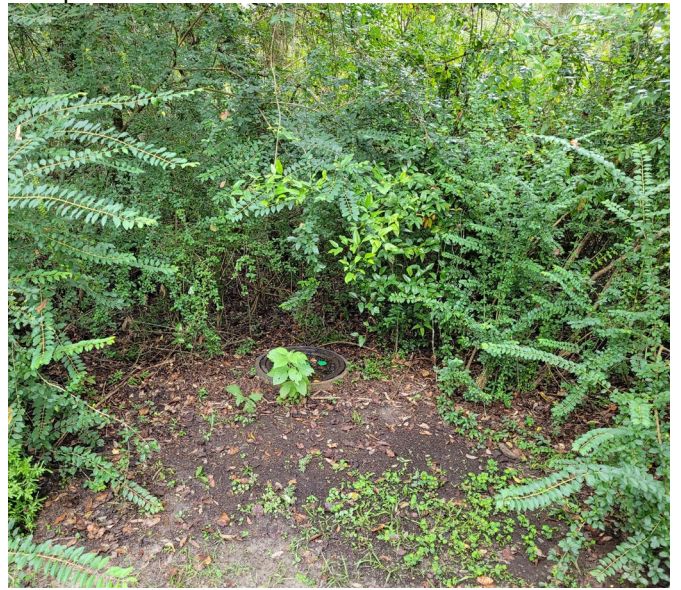
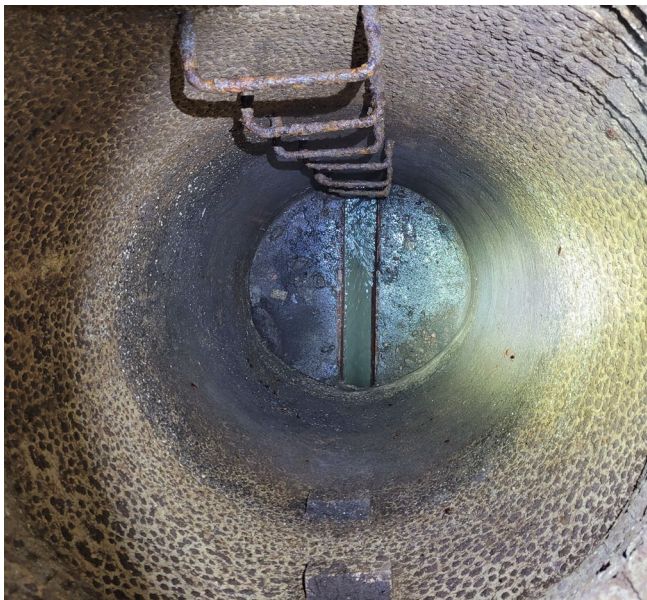
Area photo

Project: Saraland TFM 2021		Date: 6/16/21	Name: J. Rodgers
Manhole #: SA-NC-00-039	Pipe Diameter: 8"	Pipe Material: VCP	
Address/Location: Behind 204 McKeough Ave in edge of woods			
Town: Saraland			
Latitude: N 30°48.84408'		Longitude: W 88°04.5819'	Access: Walk
Safety: Standard, CSE		Manhole Depth: 12'6"	
Gas Investigation: Good	Manhole Condition: Fair	Traffic: Standard	
Flow Meter: Flowav	Serial #: 293665	Sensor Configuration: pressure depth, Doppler Velocity

Site Comments: evidence of surcharge. Sensor is installed in the upstream pipe.

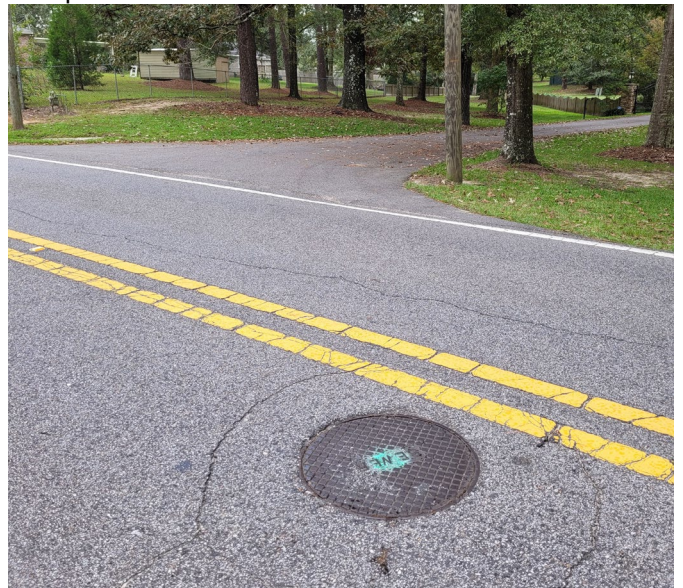
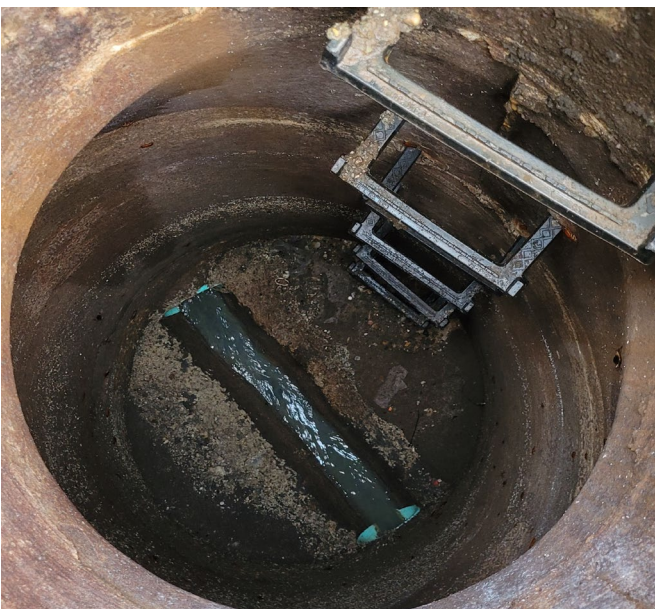
Area photo

Project: Saraland TFM 2021		Date: 6/16/21	Name: J. Rodgers
Manhole #: SA-NC-00-095	Pipe Diameter: 10"	Pipe Material: PVC	
Address/Location: Cleveland Rd just north of Sara Oaks Dr			
Town: Saraland			
Latitude: N 30°48.6747'		Longitude: W 88°05.1918'	Access: Drive
Safety: Standard, CSE		Manhole Depth: 10'7"	
Gas Investigation: Good	Manhole Condition: Fair	Traffic: Standard	
Flow Meter: Flowav	Serial #: 293467	Sensor Configuration: pressure depth, Doppler Velocity

Site Comments: evidence of surcharge. Sensor is installed in the upstream pipe.

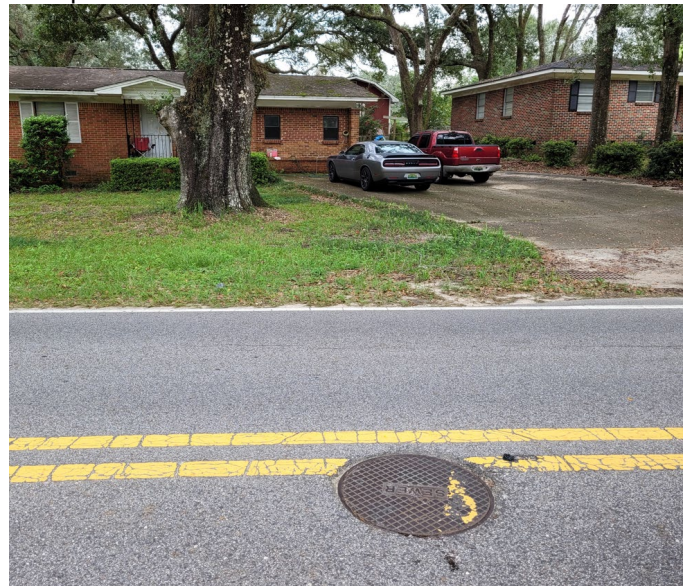
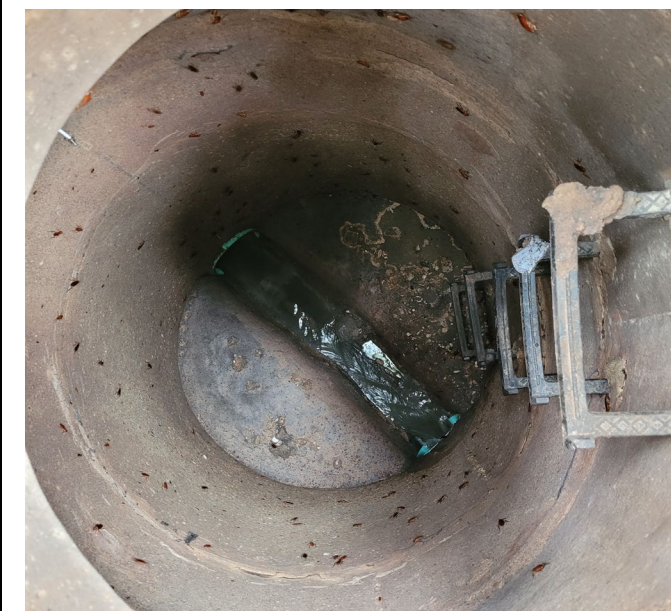
Area photo

Project: Saraland TFM 2021		Date: 6/16/21	Name: J. Rodgers
Manhole #: SA-NC-00-114	Pipe Diameter: 10"	Pipe Material: PVC	
Address/Location: Cleveland Rd in front of Cleveland Rd Church of God			
Town: Saraland			
Latitude: N 30°48.71478'		Longitude: W 88°05.21772'	Access: Drive
Safety: Standard, CSE		Manhole Depth: 9'5"	
Gas Investigation: Good	Manhole Condition: Fair	Traffic: Standard	
Flow Meter: Flowav	Serial #: 294568	Sensor Configuration: pressure depth, Doppler Velocity

Site Comments: evidence of surcharge. Sensor is installed in the upstream pipe.

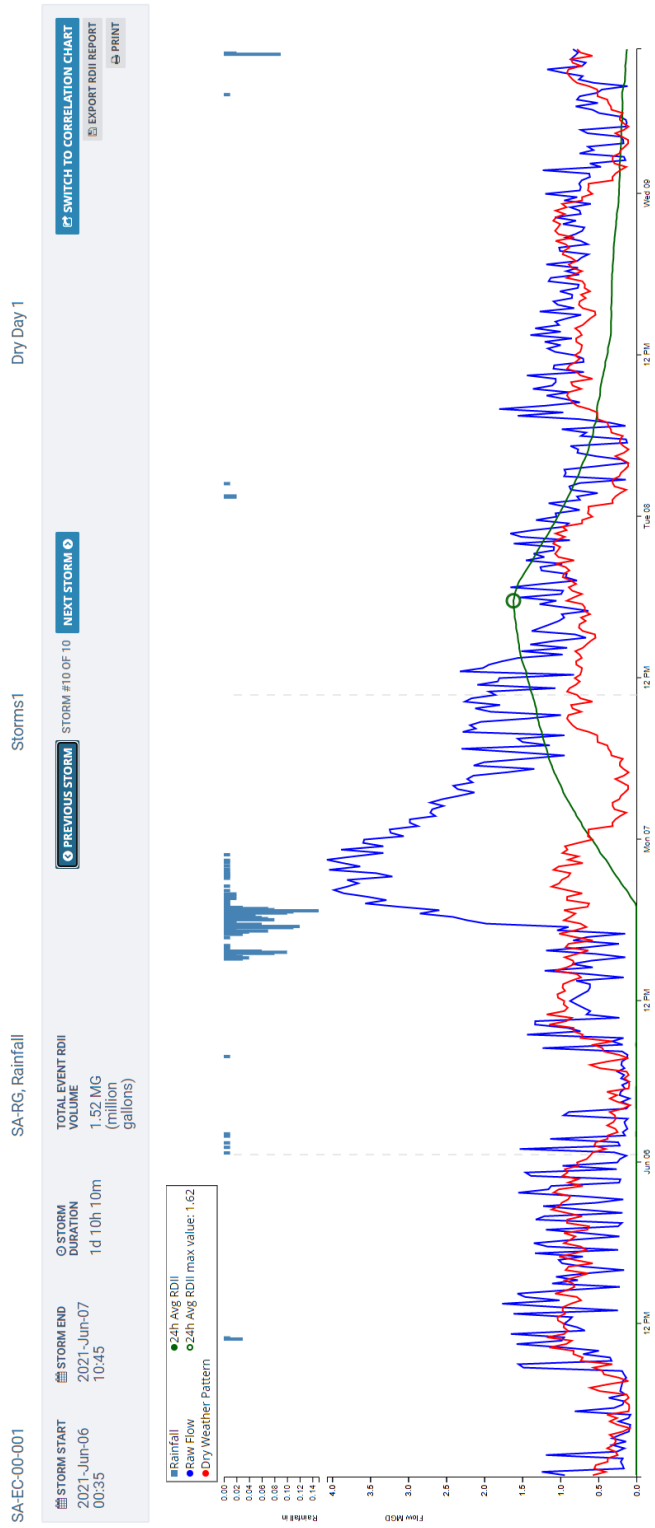
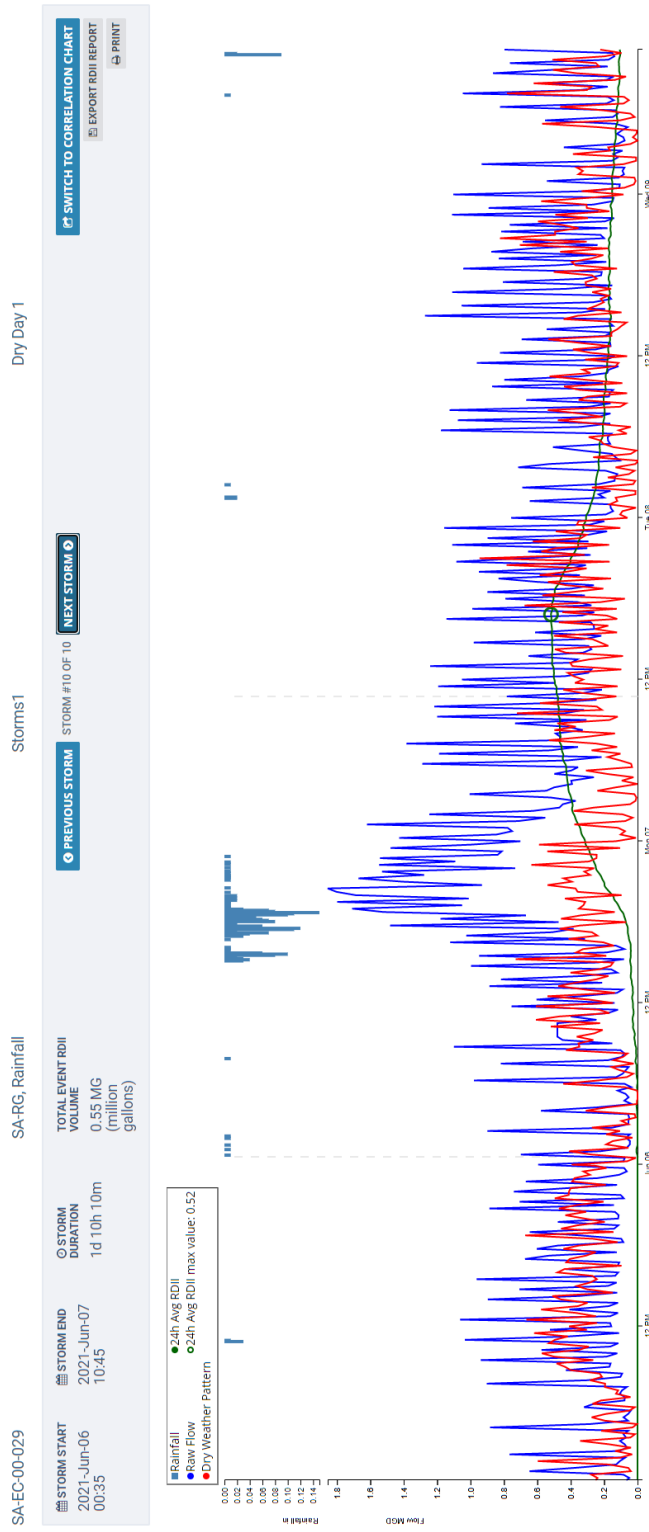
APPENDIX B. RDII HYDROGRAPHS

To determine RDII values, an RDII Hydrograph was generated in FlowWorks for each rain event at each site. RDII Hydrographs for a selected rain event for all sites are included in **Appendix B**. The dark blue line represents the actual flow recorded for the wet weather event. The green line represents the dry weather flow pattern. The brighter red line represents the one hour average RDII, which is the difference between the actual flow and the dry weather pattern. By subtracting the dry weather flow pattern from the flow pattern associated with the rain event, RDII amounts were determined for each event.

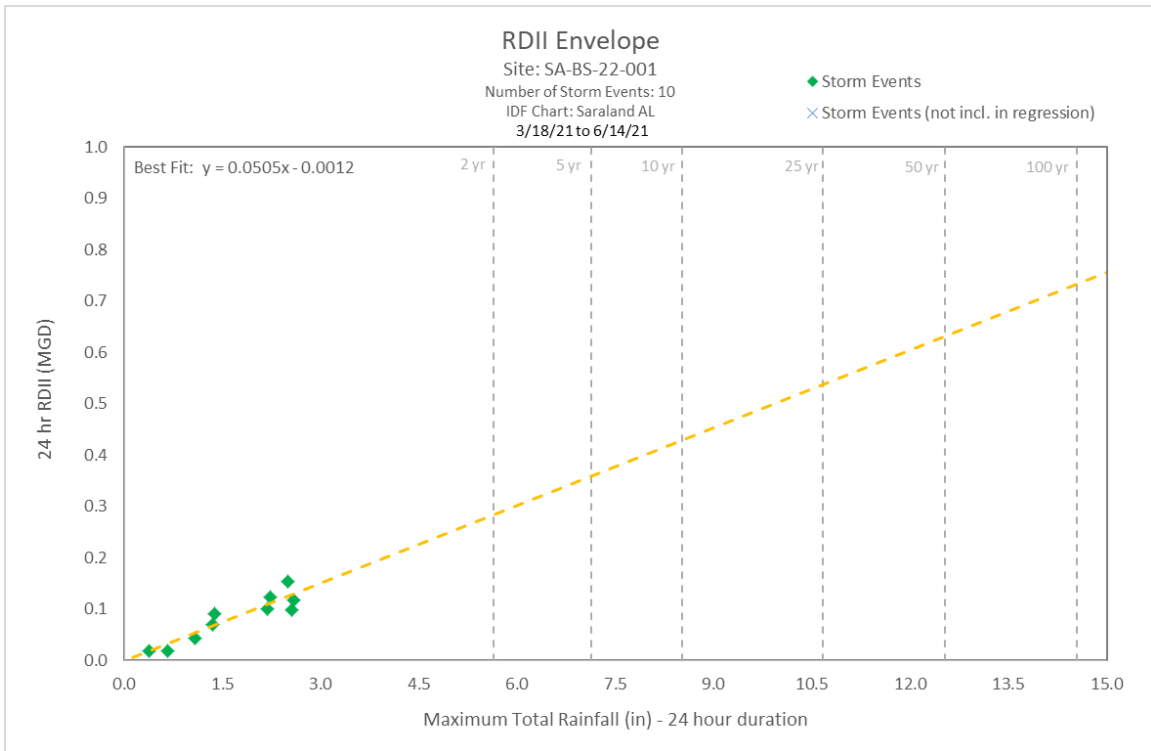
APPENDIX C. REGRESSION ANALYSES

Then a regression analysis was completed for each site. Plots of this analysis for all 10 sites are presented in **Appendix C**. For each site, the 24-hour flow volume was paired with the contributing 24-hour rain amount for each of the analyzed rains. This allows for the determination of a projected RDII volume that would result from a 2-year, 24-hour storm event.
